ZINSCO

ZINSCO SLYVANNIA

All Zinsco panels have problems with corroded bus bars, improper tripping, and loose breakers. This was the first panel company to manufacturer the main bus and components from Aluminum and many failures have been recorded.

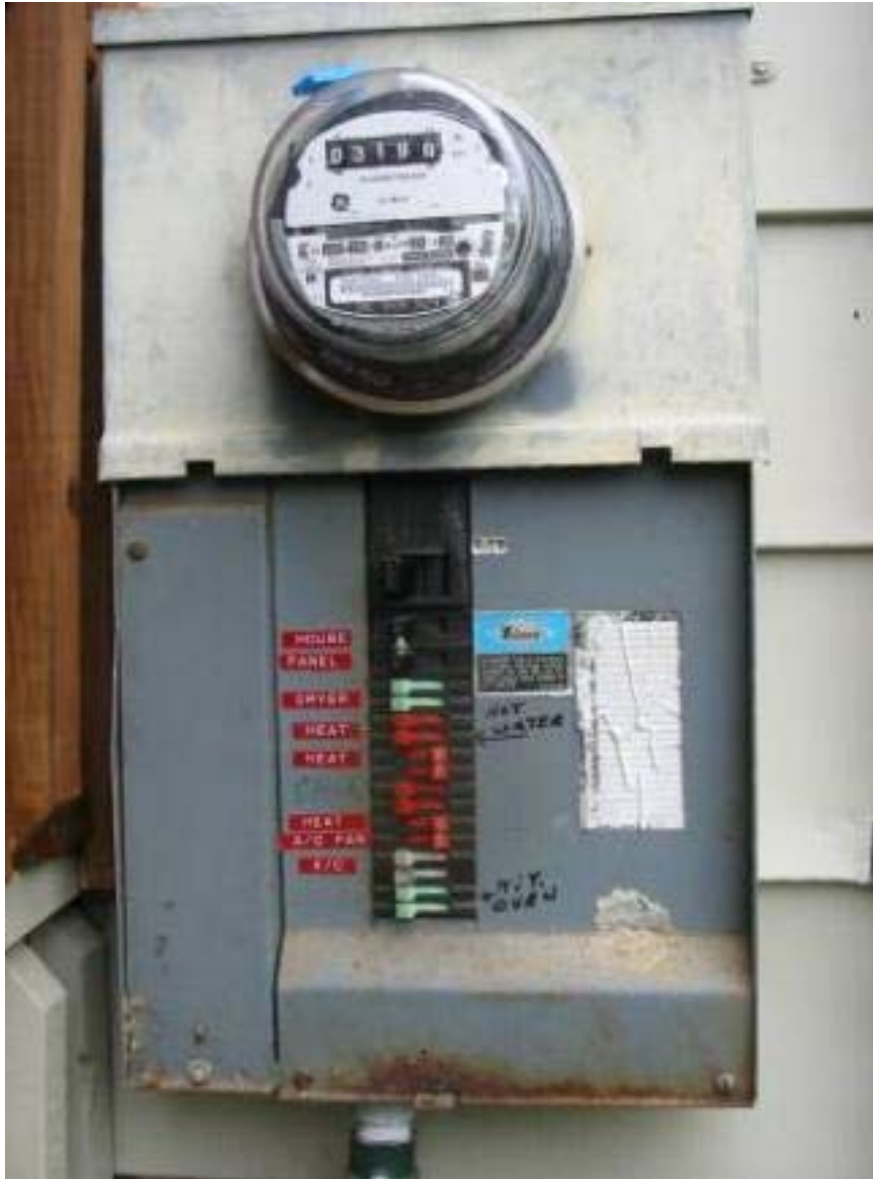
EXTERIOR ZINSCO PANEL WITH POWER METER COMBINATION

The panel in the next photo is not safe for you to remove. The metal cover extends up toward the main meter and can touch he main meter bus. There is no safety stop to protect you.

THIS PANEL IS **NOT** SAFE FOR THE INSPECTOR TO REMOVE THE COVER. DEATH OR SERIOUS INJURY CAN RESULT. THERE IS NOT SAFETY STOP BETWEEN THE COVER AND THE MAIN POWER BUS FROM THE

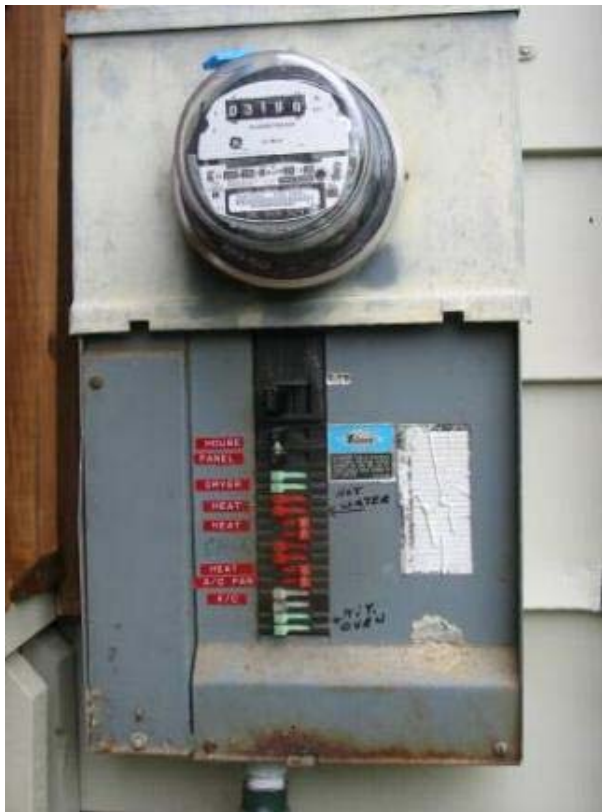
EXTERIOR ZINSCO PANEL WITH POWER METER COMBINATION

The main electrical meter panel for this home was originally owned by the Power Company. The inspection panel cover of this panel cannot be safely removed during a home inspection because it was designed to be removed by the Power Company when the meter was off. This ZINSCO panel has known problems with corrosion, and limited availability of replacement parts. Several concerns were noted: (list concerns...such as loose breakers, leaning breakers, visible corrosion, missing door, improper or missing panel labels, no ground rod or plumbing bond, not secure to home or any other visual defect noted when panel was observed **NEED ONE TO SEND FOR REPAIR.....**) This panel is in need of further evaluation and repair/replacement by a licensed electrician.

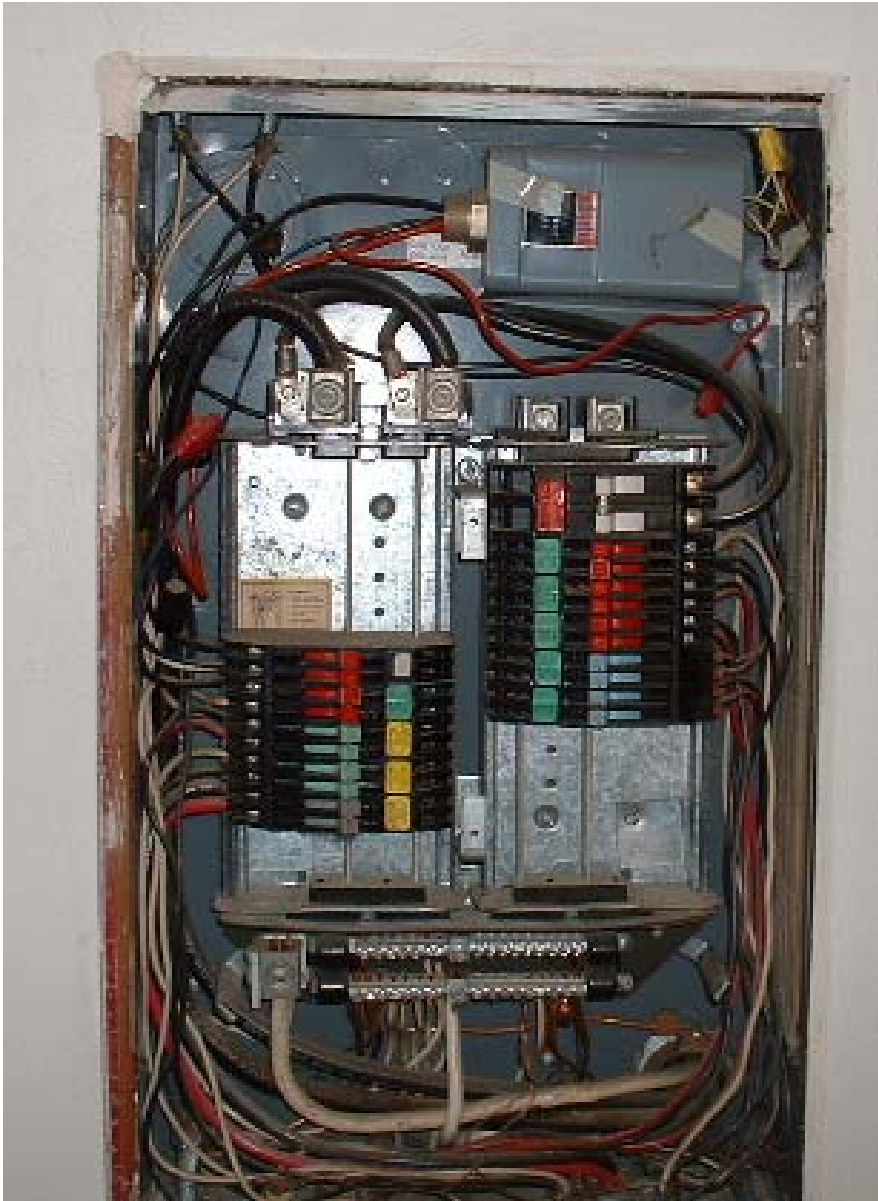
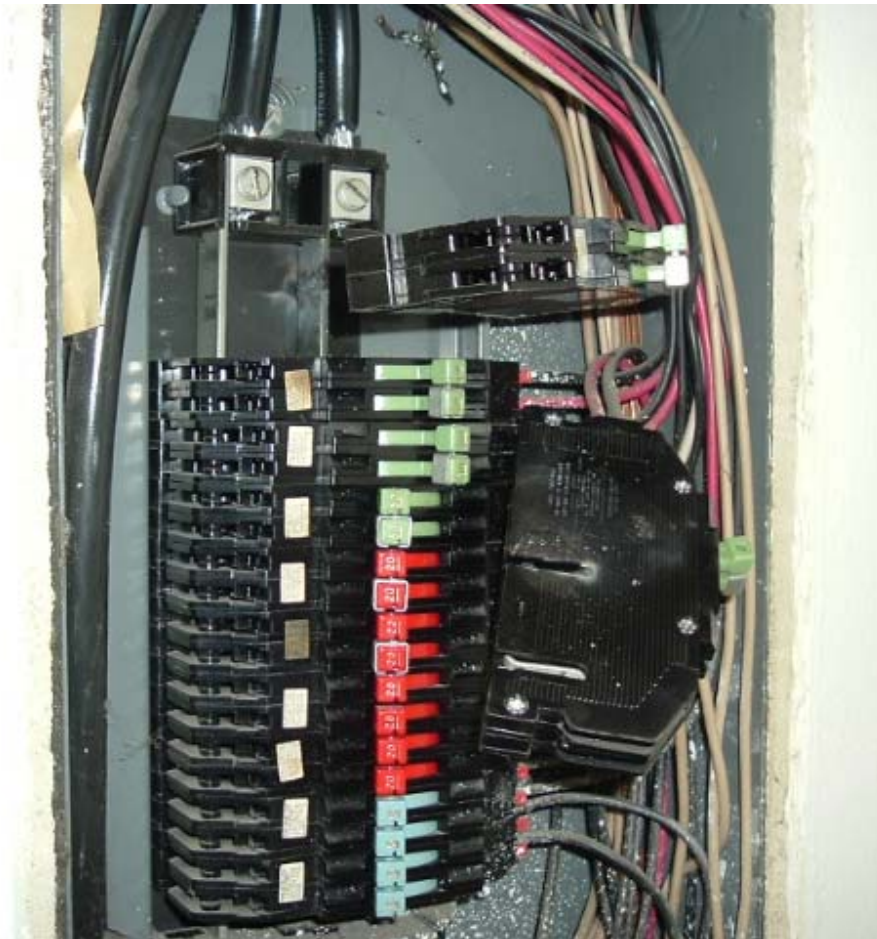
INTERIOR ZINSCO PANELS AND DEFECTS

Note the corrosion on bus where the breaker was installed. This top breaker was hot when tested and an ozone burning odor was noted.

This breaker was removed by a licensed electrician.

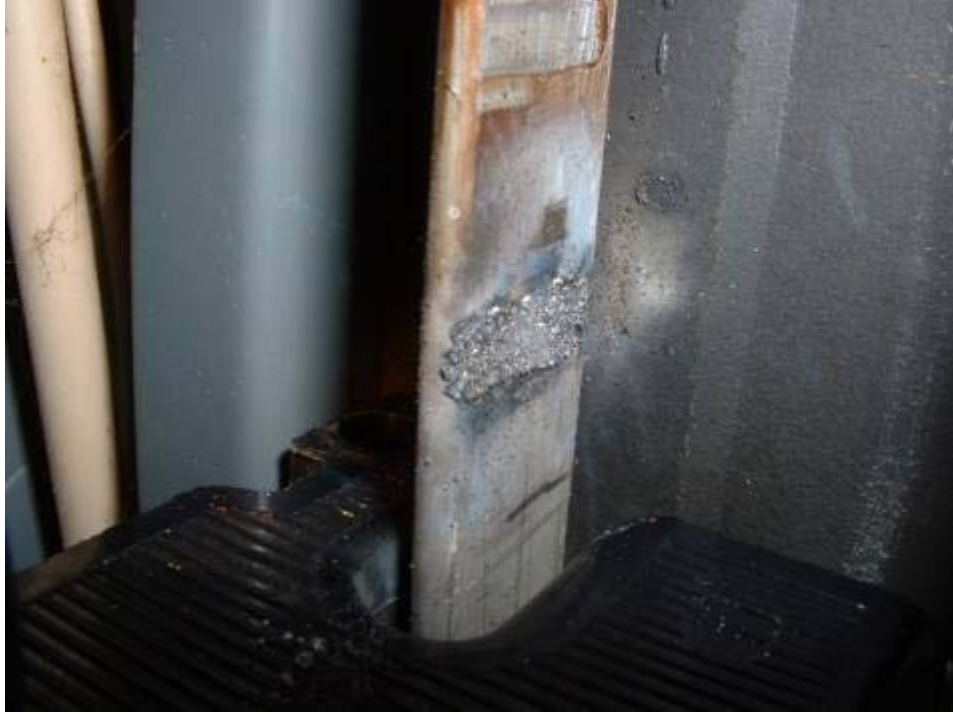
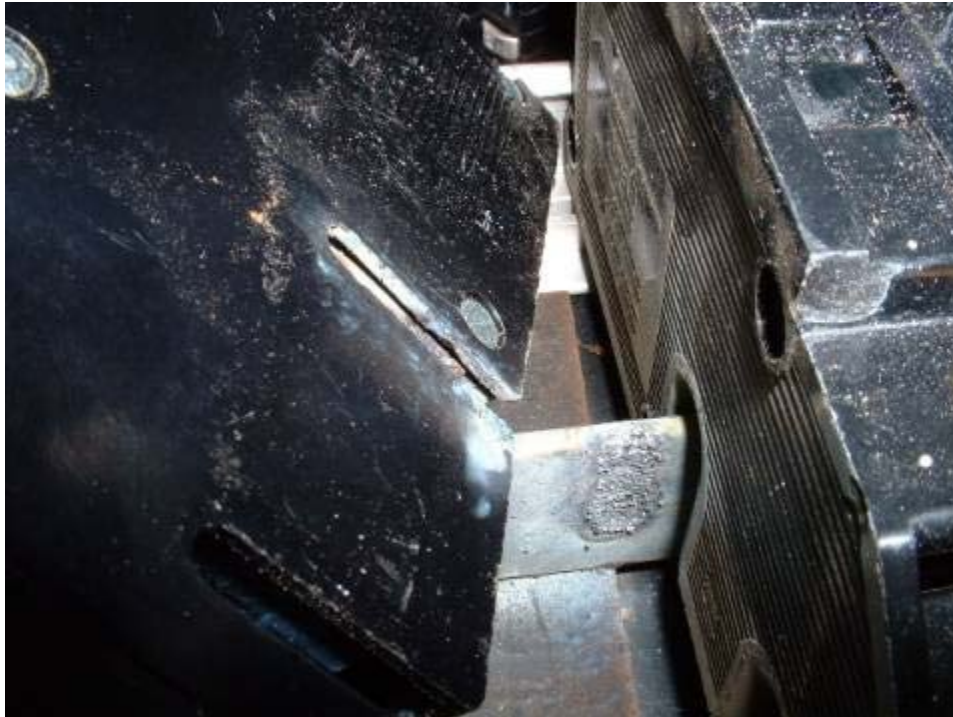
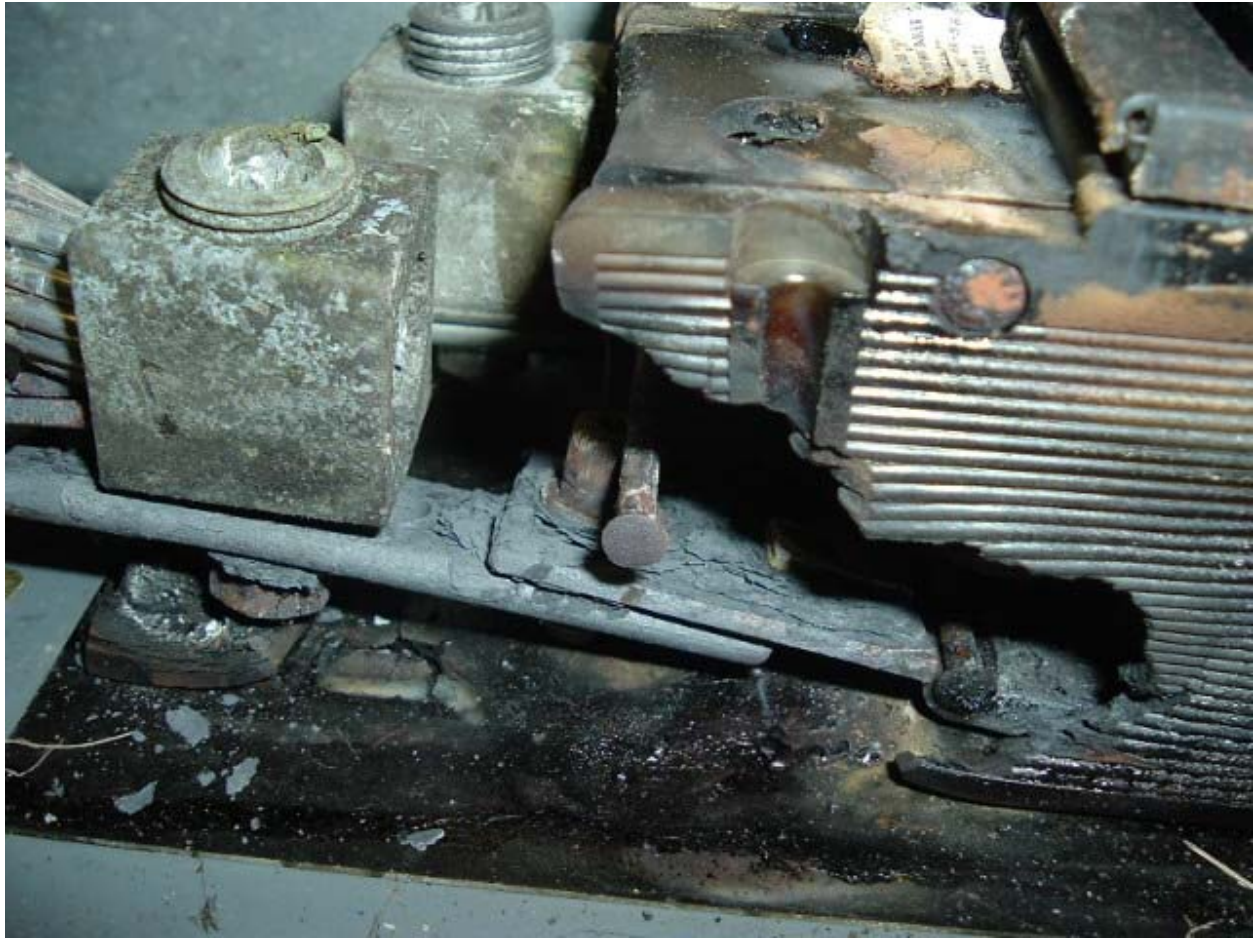
Failure or corrosion of the aluminum bus created arc and flash fire and melted the main breaker. **The home inspector removed this panel, but it was a hazard, look at the breaker condition before you remove the panel.**
