ZINSCO

ZINSCO SLYVANNIA

All Zinsco panels have problems with corroded bus bars, improper tripping, and loose breakers. This was the first panel company to manufacturer the main bus and components from Aluminum and many failures have been recorded.

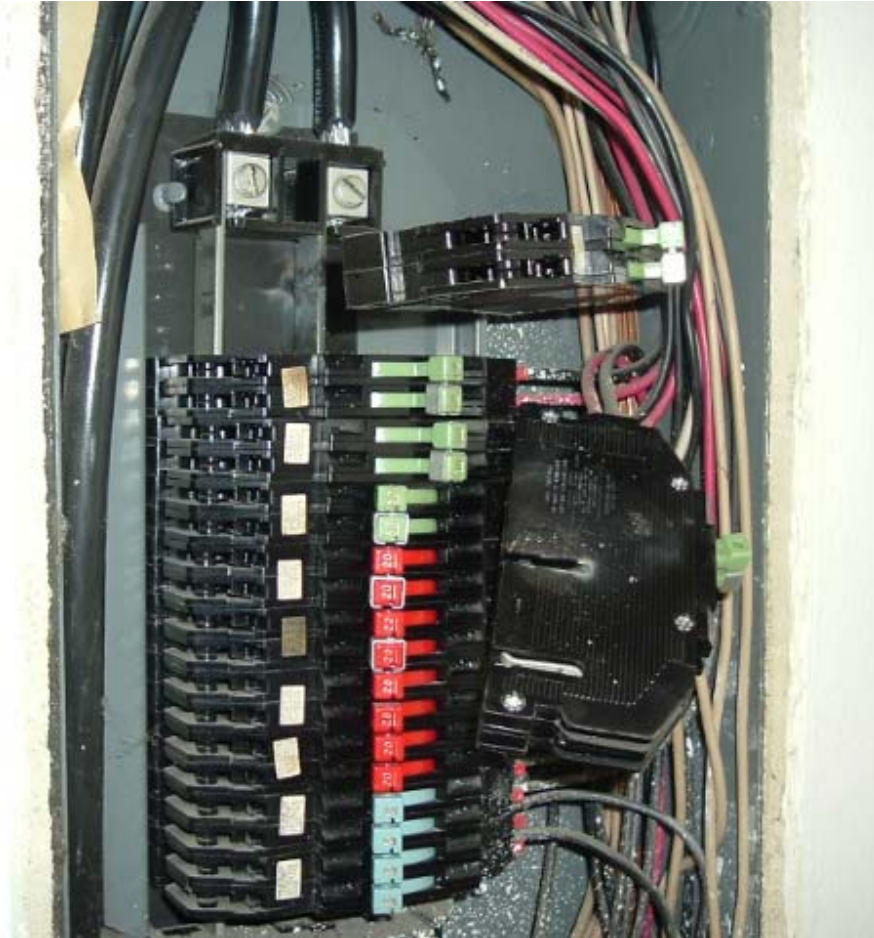
Note the corrosion on bus where the breaker was installed. This top breaker was hot when tested and an ozone burning odor was noted.

This breaker was removed by a licensed electrician.

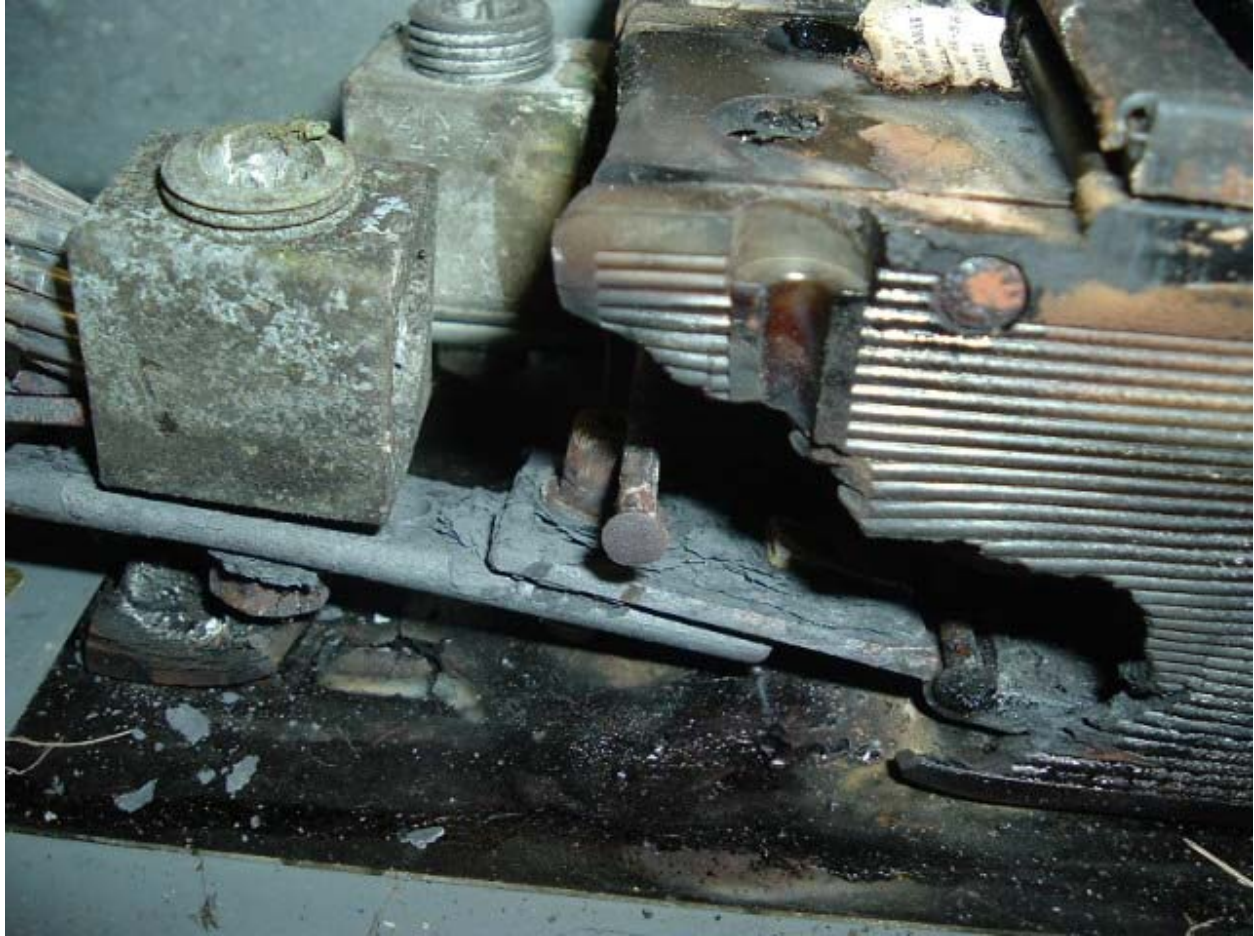
Failure or corrosion of the aluminum bus created arc and flash fire and melted the main breaker. **The home inspector removed this panel, but it was a hazard, look at the breaker condition before you remove the panel.**
