ZINSCO

ZINSCO SLYVANNIA

All Zinsco panels have problems with corroded bus bars, improper tripping, and loose breakers. This was the first panel company to manufacturer the main bus and components from Aluminum and many failures have been recorded.

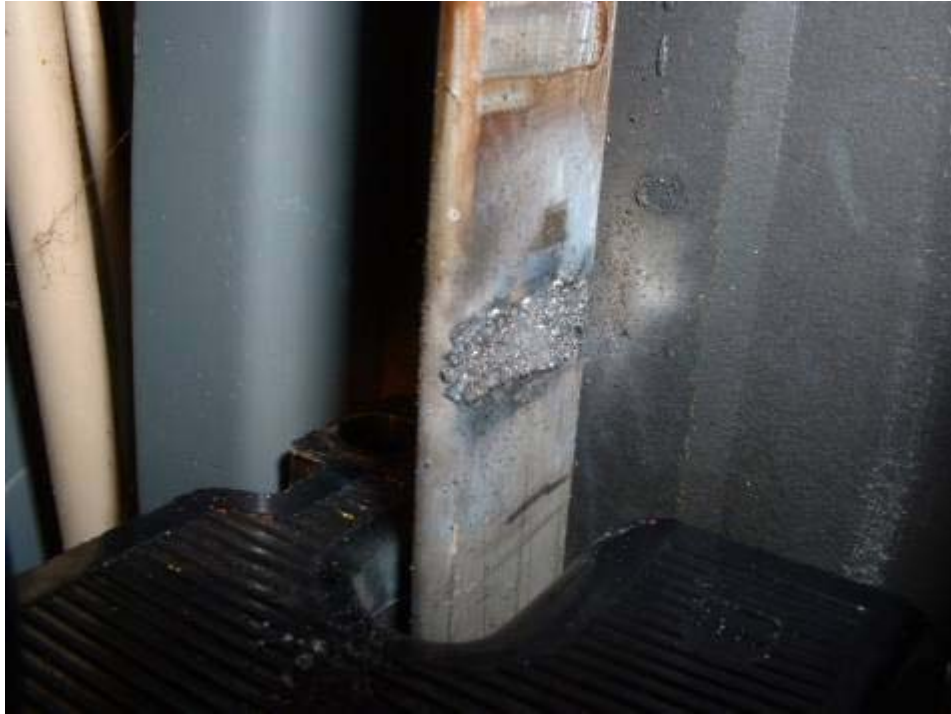
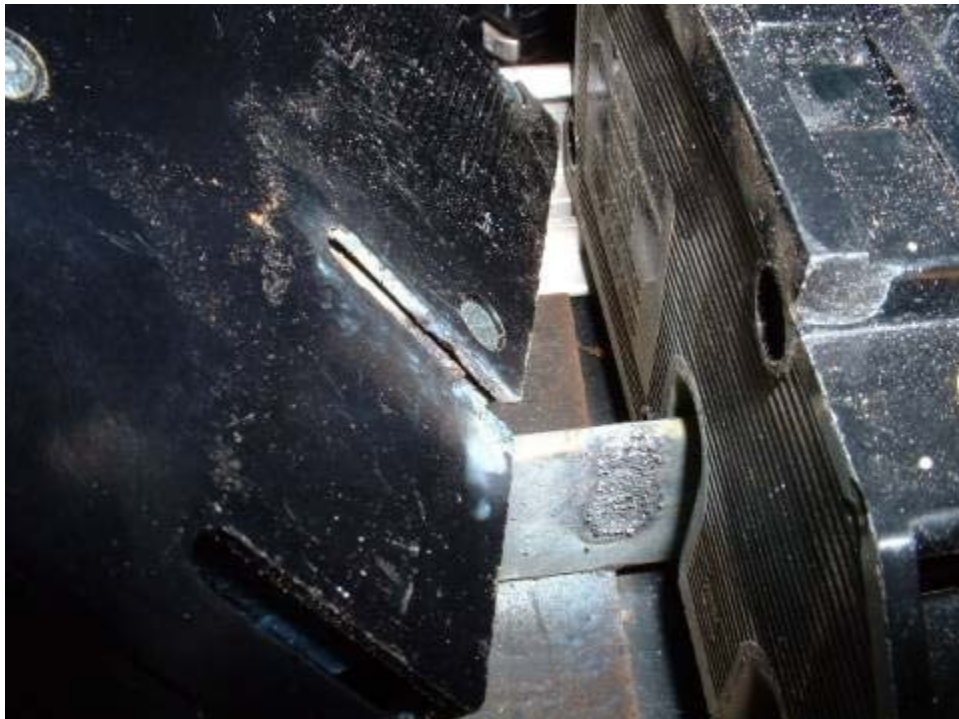
Note the corrosion on bus where the breaker was installed. This top breaker was hot when tested and an ozone burning odor was noted.

This breaker was removed by a licensed electrician.
